**U.S. EPA REGION VIII
TECHNICAL ENFORCEMENT PROGRAM
RCRA CORRECTIVE ACTION ASSESSMENT REPORT**

Facility: Asarco East Helena Plant
100 Smelter Road
East Helena, MT

Inspection Type: Corrective Action Assessment Inspection

Date: April 30, 2008
Time In: 10:15 a.m.
Time Out: 1:50 p.m.

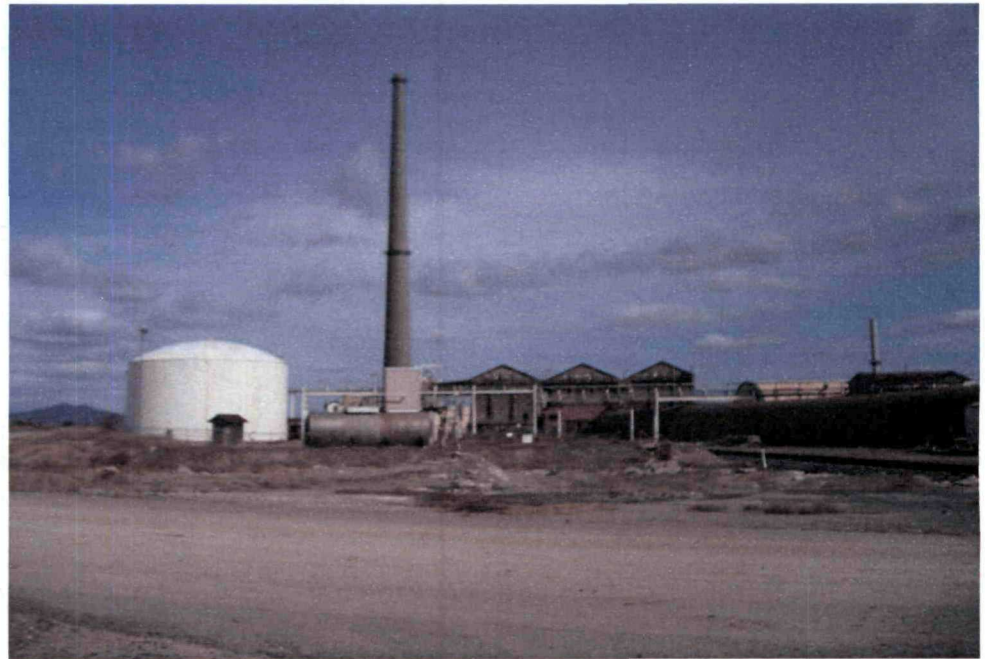
Photo 1; Facility: Asarco East Helena Smelter; Subject: Baghouse and Stack;
Date: April 30, 2008; Photographer:
Linda Jacobson

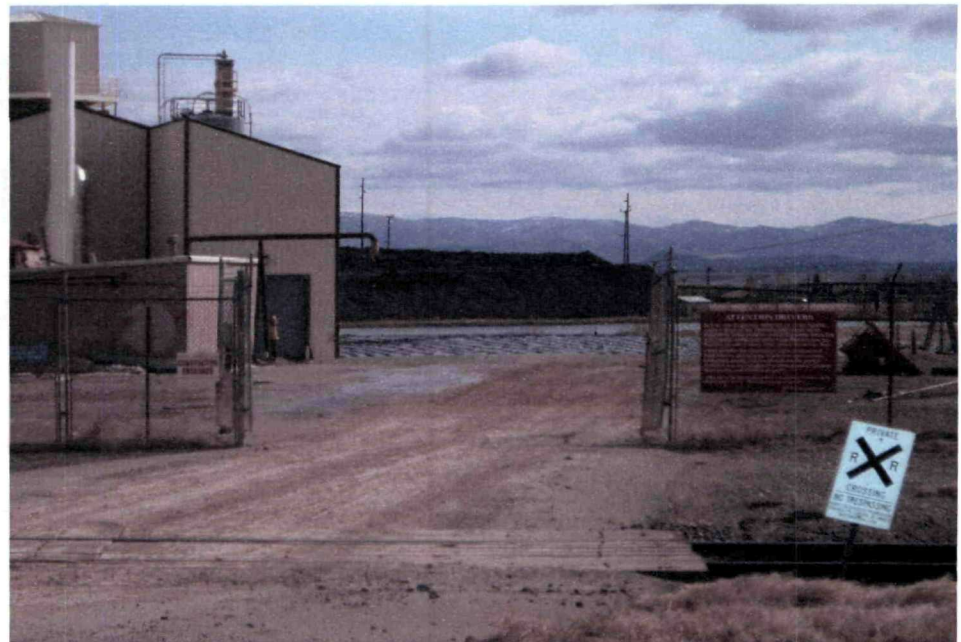
Photo 2; Facility: Asarco East Helena Smelter; Subject: Temporary Cover on Former Acid Plant Sediment Drying Area;
Date: April 30, 2008; Photographer:
Linda Jacobson

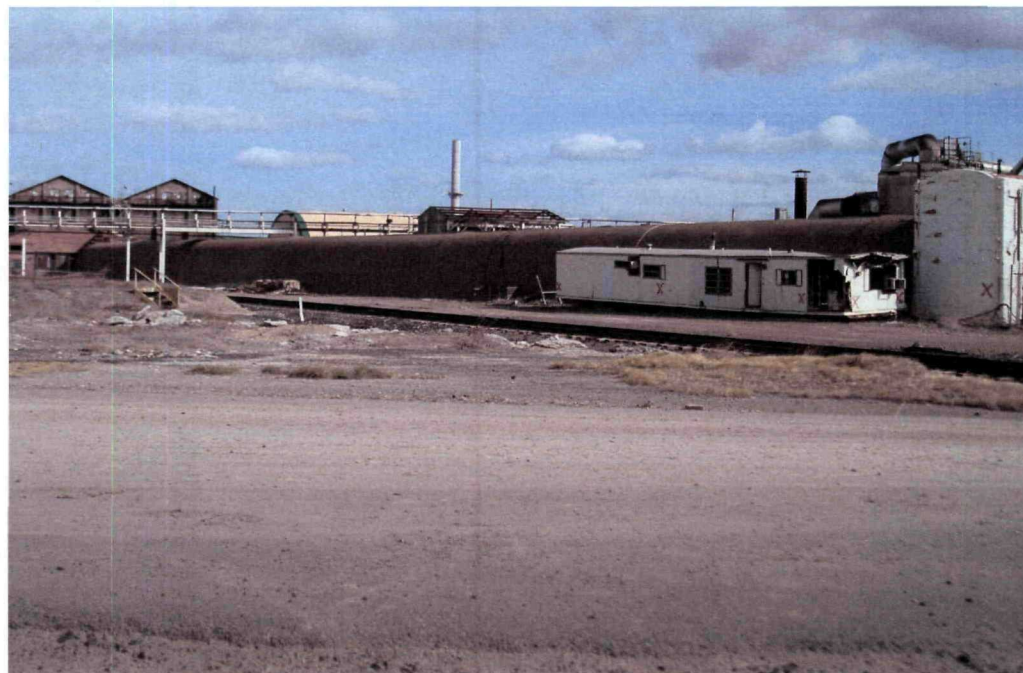
Photo 4: Facility: Asarco East Helena
Smelter; Subject: Stockpiled GCL;
Date: April 30, 2008; Photographer:
Linda Jacobson

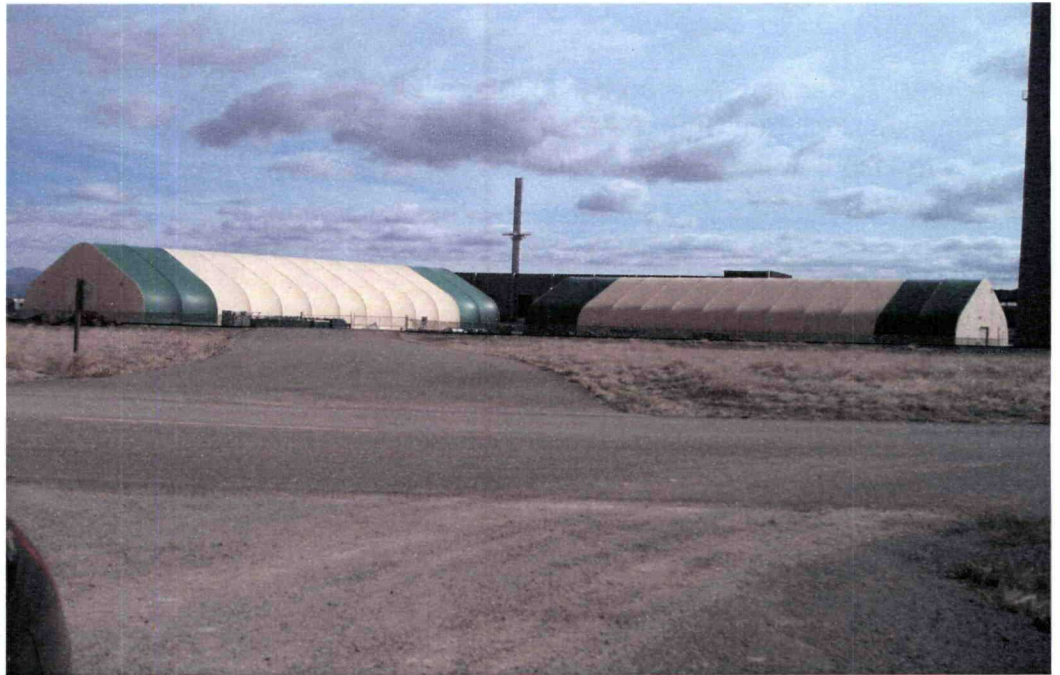
Photo 5; Facility: Asarco East Helena Smelter; Subject: Barnum & Bailey Buildings Used for Waste Storage; Date: April 30, 2008; Photographer: Linda Jacobson

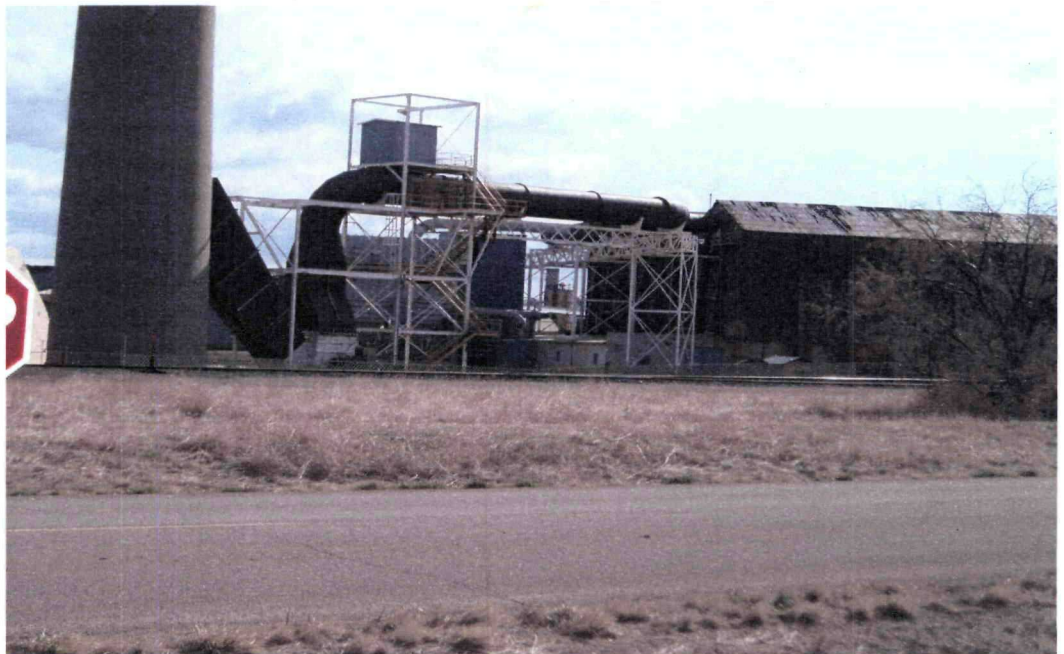
Photo 7; Facility: Asarco East Helena
Smelter; Subject: First CAMU Cell;
Date: April 30, 2008; Photographer:
Linda Jacobson

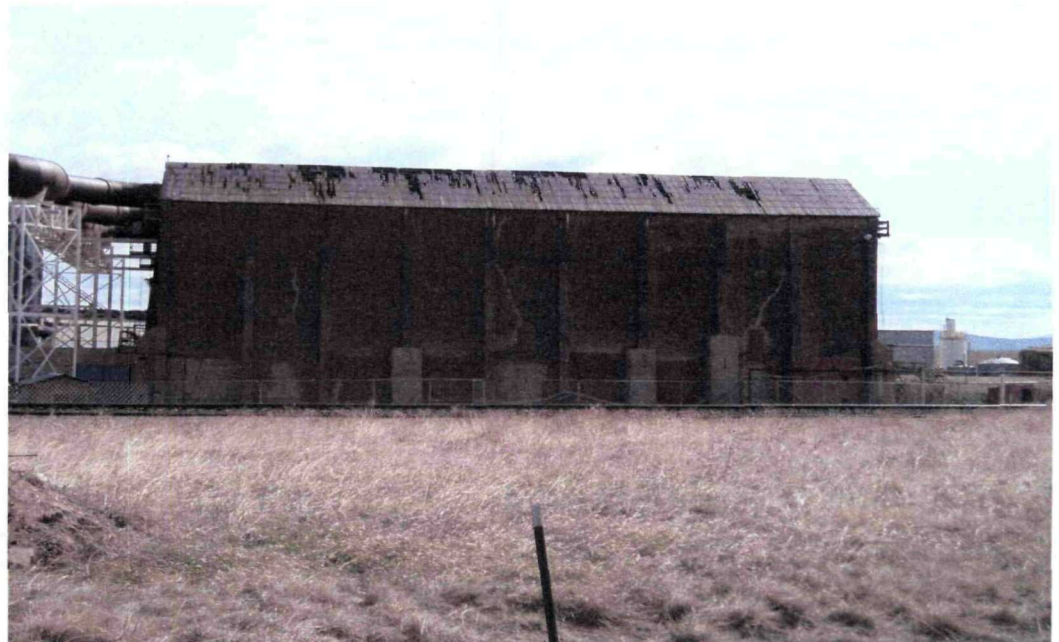
Photo 10; Facility: Asarco East Helena
Smelter; Subject: Baghouse, Note roof
from which asbestos was removed;
Date: April 30, 2008;
Photographer: Linda Jacobson

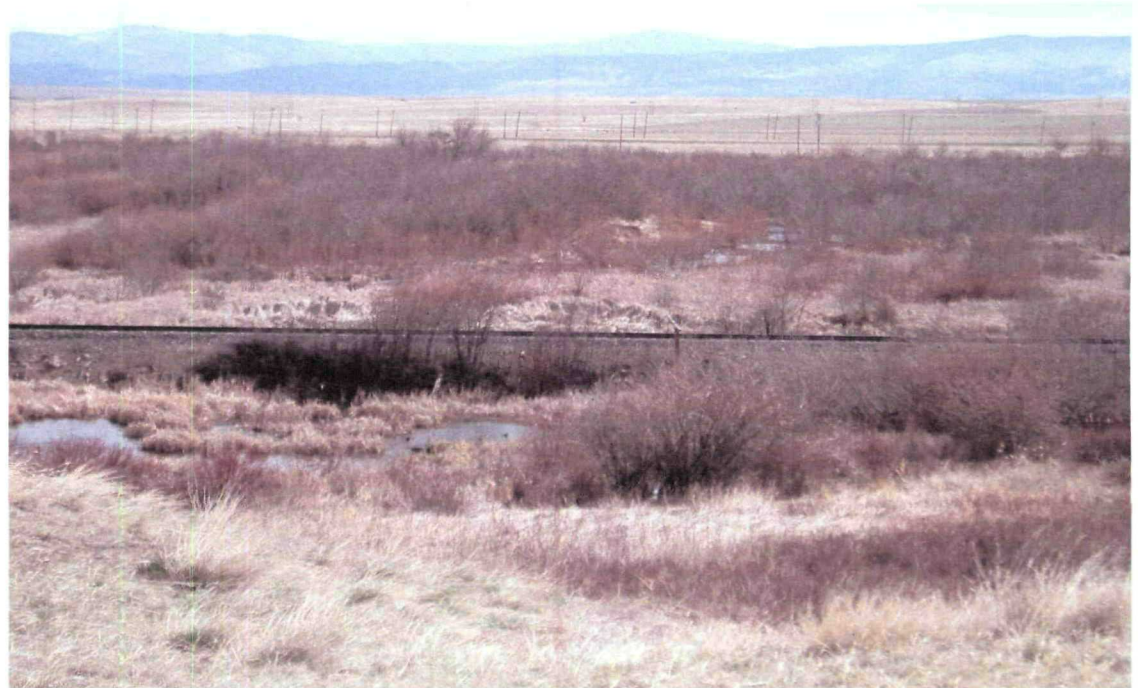
Photo 12; Facility: Asarco East
Helena Smelter; Subject: Upper Lake;
Date: April 30, 2008;
Photographer: Linda Jacobson

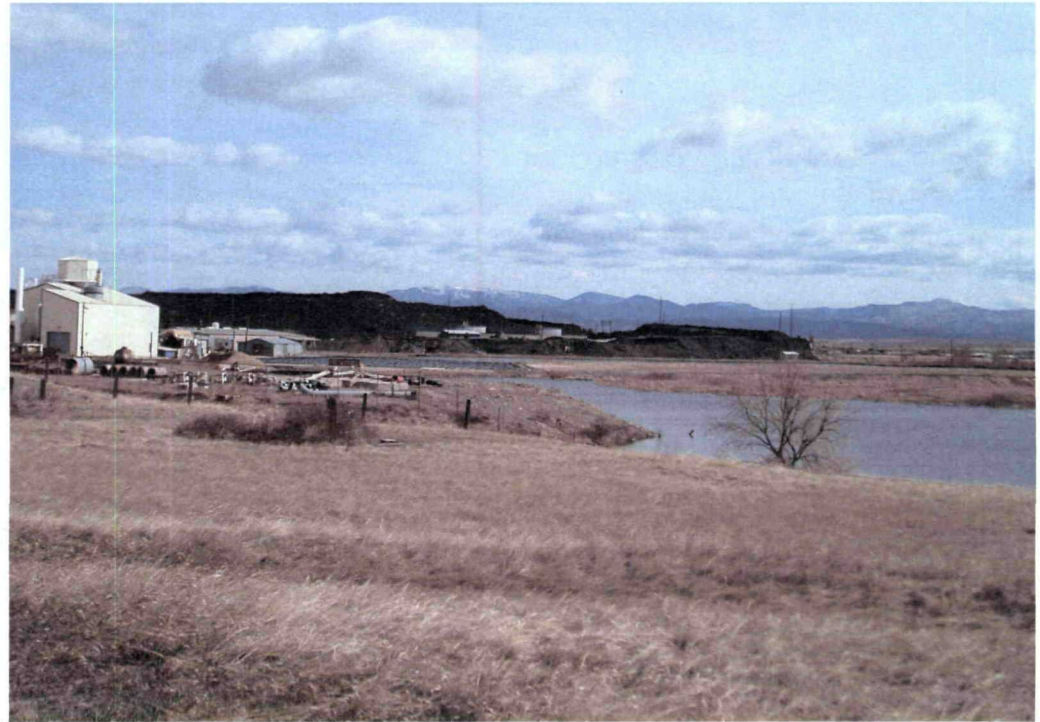
Photo: 15; Facility: Asarco East Helena
Smelter; Subject: Former Acid Plant
Sediment Drying Area Temporary Cap and
Slag Pile in Background;
Date: April 30, 2008

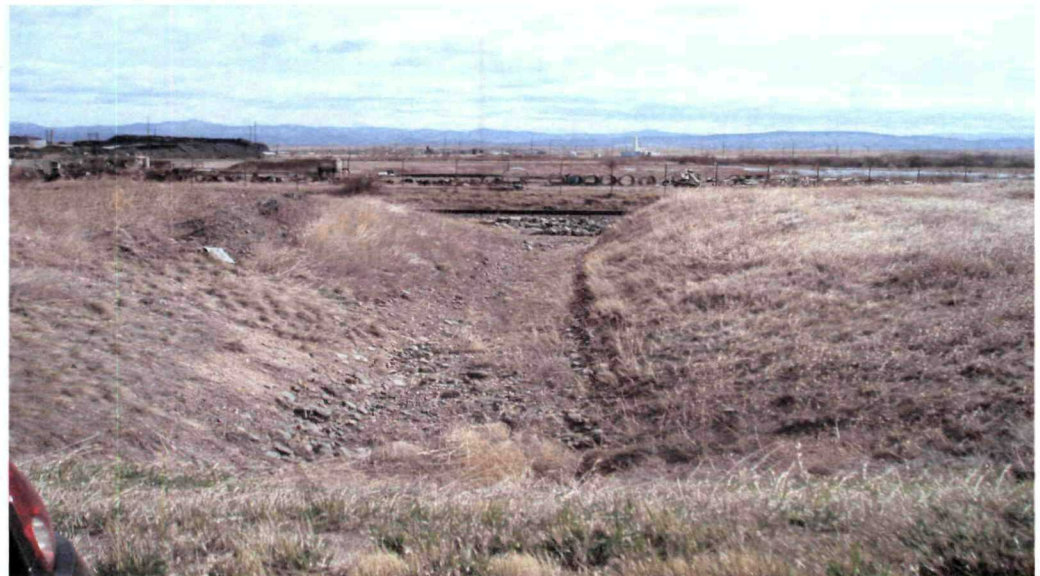
Photo 17; Facility: Asarco East
Helena Smelter; Subject: CAMU
Cell 2 Construction Site;
Date: April 30, 2008;
Photographer: Linda Jacobson

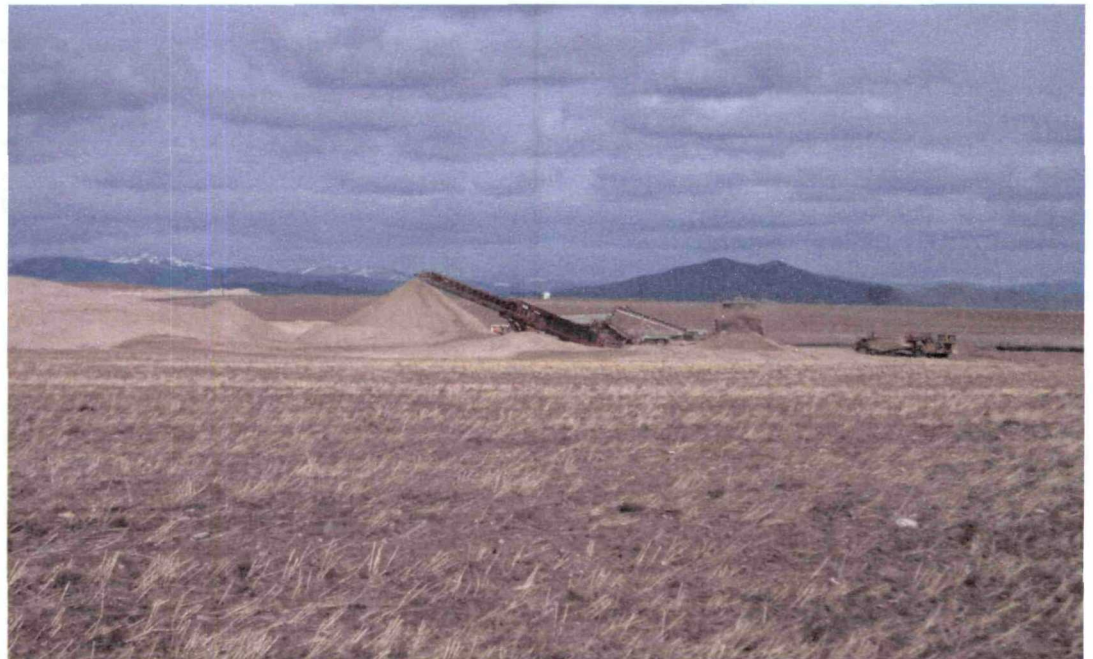
Photo 18; Facility: Asarco East
Helena Smelter; Subject: CAMU
Cell 2 Screened Stockpiles;
Date: April 30, 2008;
Photographer: Linda Jacobson

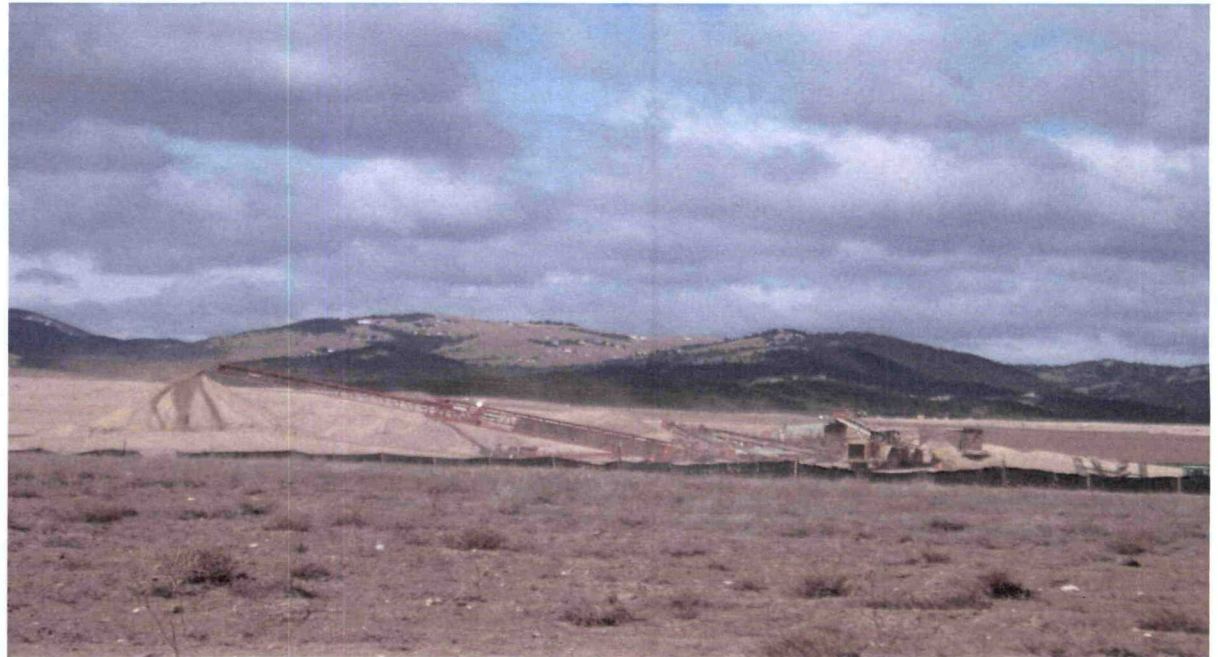
Photo 19; Facility: Asarco East
Helena Smelter;
Subject: CAMU Cell 2 Soil
Screen; Date: April 30, 2008;
Photographer: Linda Jacobson

They then proceeded to the site of the new CAMU cell, where they were met by Mark Rhodes, Hydrometrics Project Manager, Jason Rolfe, Womack and Associates, Greg Lorensen, Hydrometrics, and Shaun O'Connor, Cleveland Wrecking System Site Manager. Mr. Rhodes explained that the last lift of clay on the cell floor was being disked. The cell side slopes were to grade. The synthetic liner work will proceed from east to west beginning at the south wall. Screening of clay was continuing from the new borrow area referred to as the south excavation area.

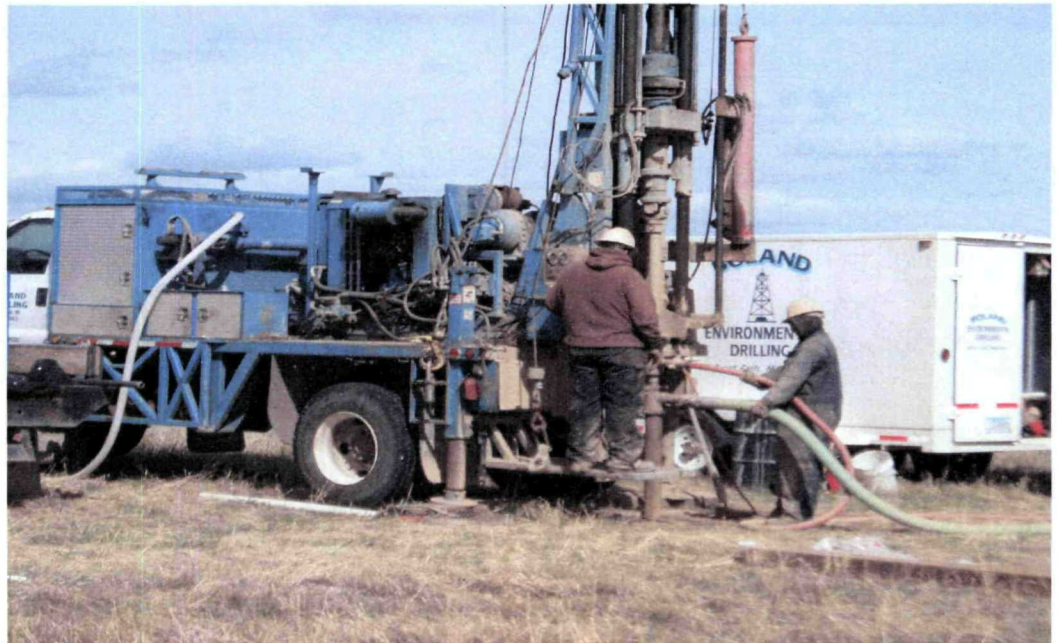
Photo 23; Subject: Asarco East
Helena Smelter;
Subject: Installation of EH-118
Date: April 30, 2008
Photographer: Linda Jacobson

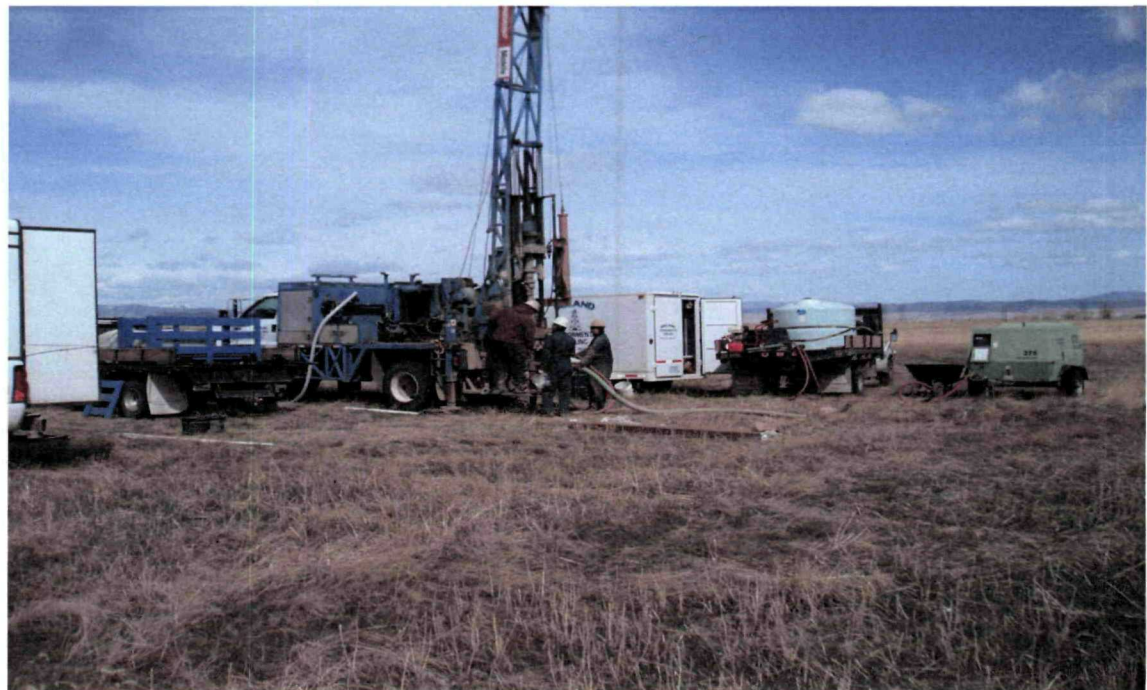
Photo 24; Subject: Asarco East
Helena Smelter; Subject: Well
Installation of MW-EH-118;
Date: April 30, 2008;
Photographer: Linda Jacobson

Ms. Jacobson drove to Lamping Fields, identified herself to Mr. Bill Thompson, Hydrometrics hydrogeologist, who was overseeing the well installation and collecting samples. Well EH-118 was being installed by Boland Environmental out of Great Falls, Montana. Wells DH-68, DH-71, EH-119, EH-121, EH-68, and EH-69 had been installed. There were access issues with installation of wells EH-67 and EH-122. Well EH-120 was still to be drilled in Lamping Field later that week.

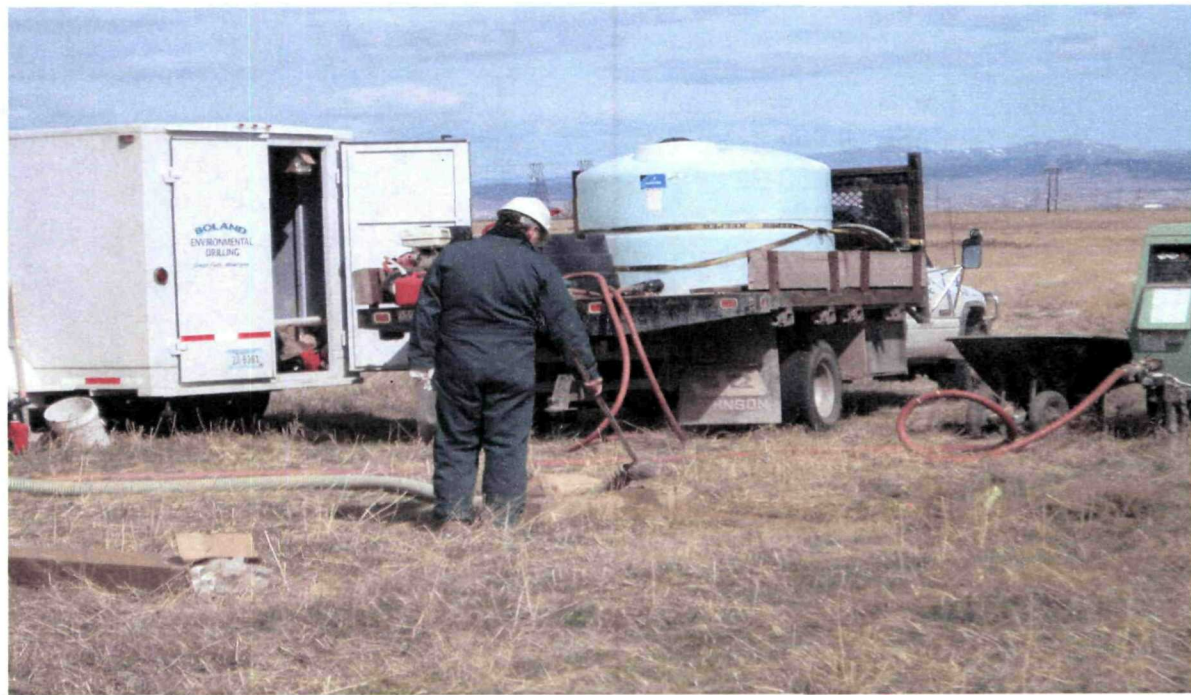
Photo 25; Facility: Asarco East
Helena Smelter; Subject:
Collection of Cuttings Sample;
Date: April 30, 2008
Photographer: Linda Jacobson

Mr. Thompson explained that they would collect split spoon samples at 5 foot intervals beginning at 15 feet and continuing to completion. He was also collecting grab samples of the cuttings. Ms. Jacobson looked at the core collected from the 25 to 27 foot zone. There was a lot of silt, coarse sand and gravel. He indicated that he was starting to see more sand at this depth. Ms. Jacobson also observed and photographed the split spoon coring collected from the 30 to 32 foot zone. At the 35-37 foot zone, the cuttings were a little wet; Mr. Thompson explained that this is really productive sand and gravel. The core for this zone was moist, with some fines and fairly coarse. The 37 to 40 feet zone was located below the water table; the 40 to 42 foot zone was silty fine sand.

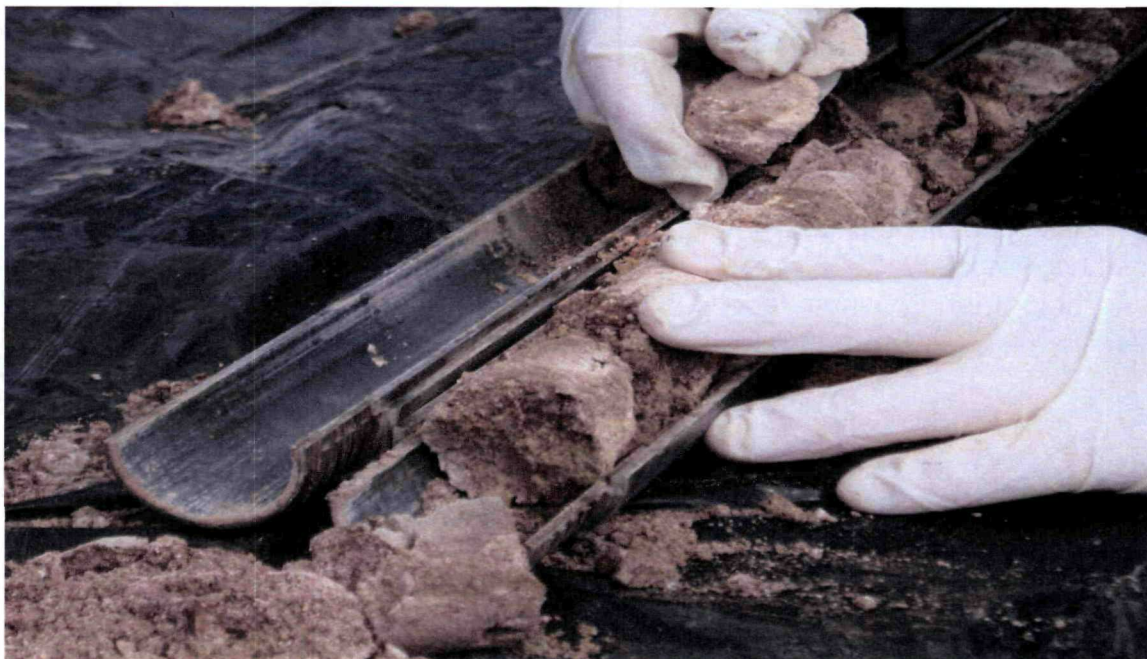
Photo 27; Facility: Asarco East
Helena Smelter; Subject: Split
Spoon Sample from 30-32';
Date: April 30, 2008
Photographer: Linda Jacobson

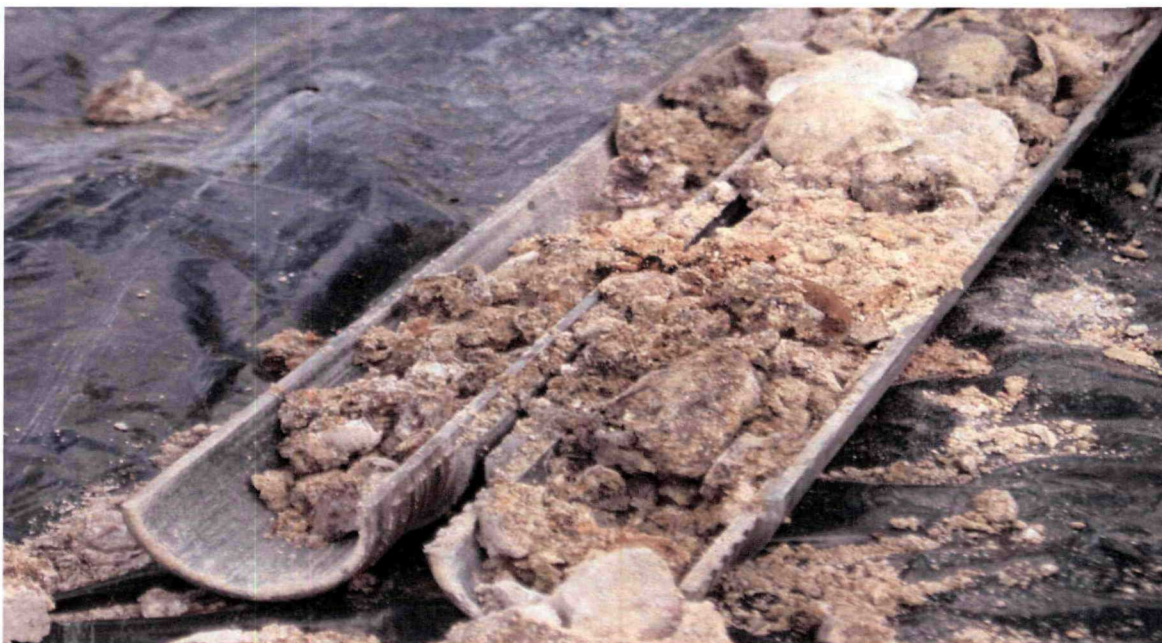
Photo 29; Facility: Asarco East
Helena Smelter; Subject:
Split Spoon Sample;
Date: April 30, 2008
Photographer: Linda Jacobson

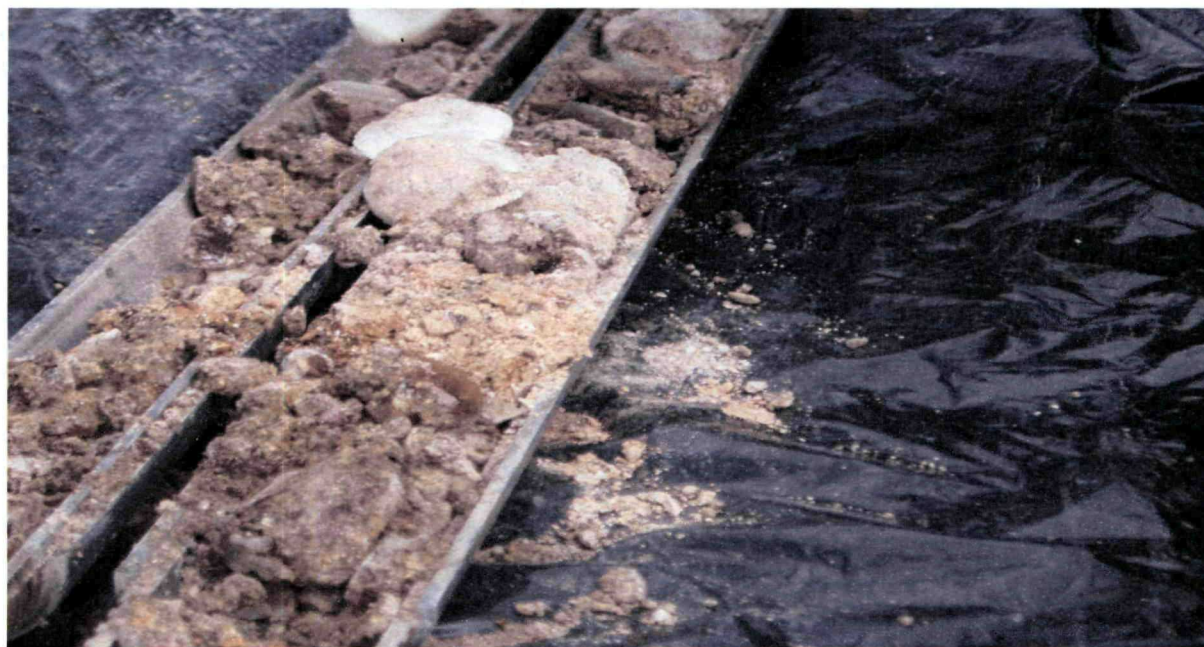
Photo 30; Facility: Asarco East
Helena Smelter; Subject: Split
Spoon Sample, 35-37'
Date: April 30, 2008;
Photographer: Linda Jacobson

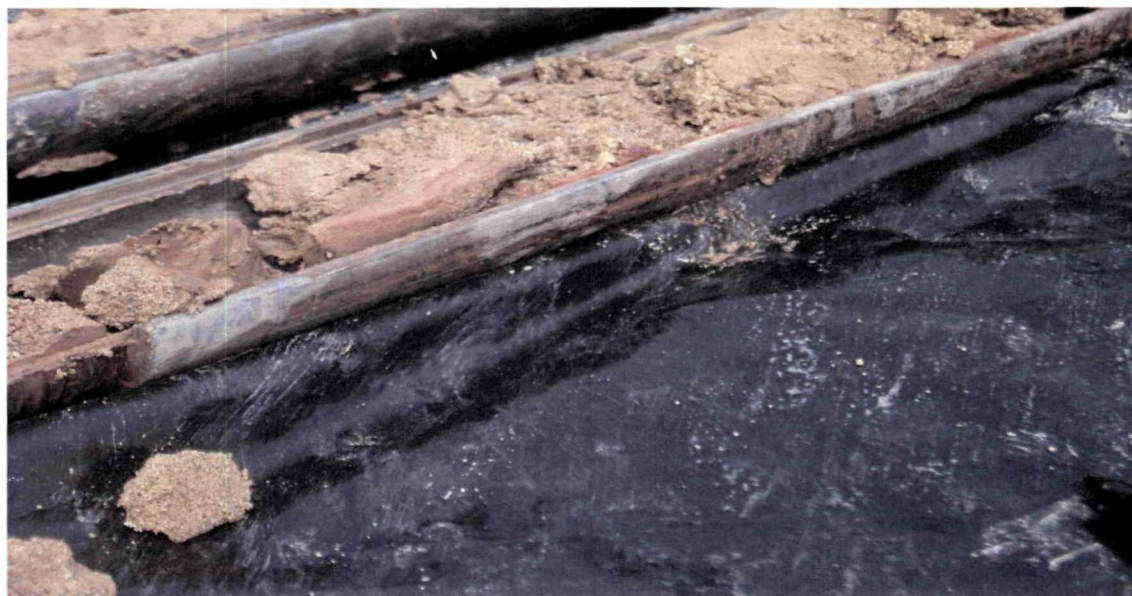
Photo 32; Facility: Asarco East
Helena Smelter; Subject: Sample
From EH-118; Date: April 30, 2008;
Photographer: Linda Jacobson

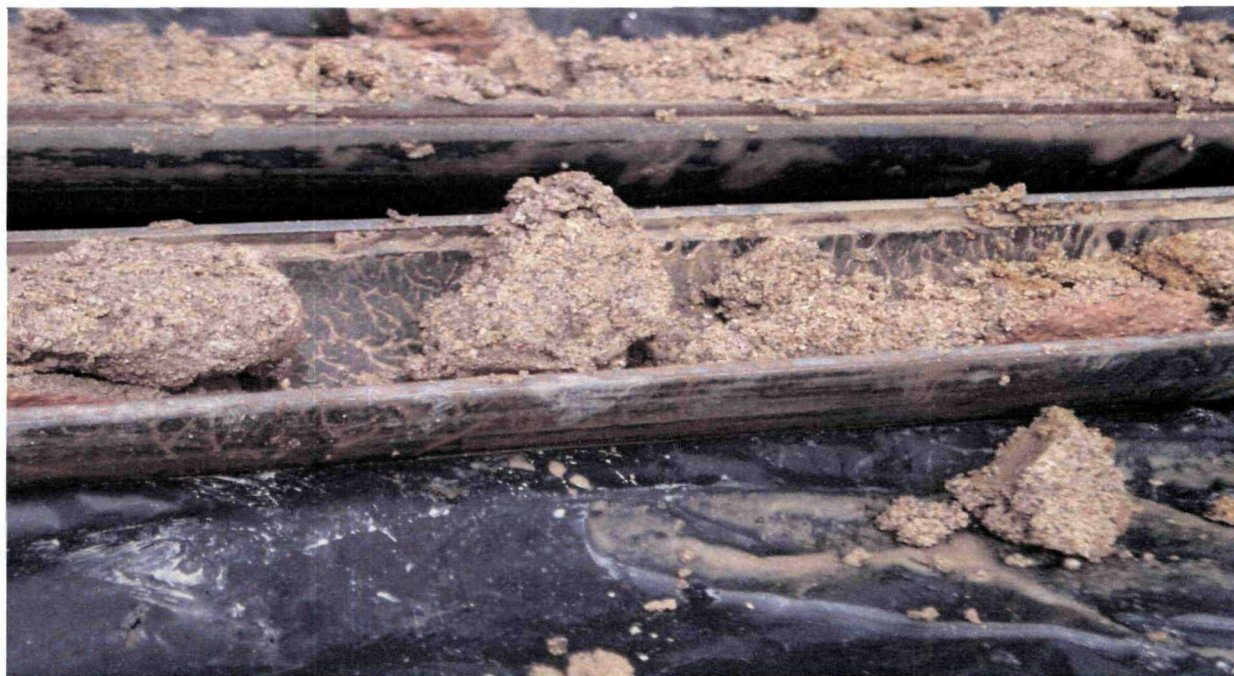
Photo 33; Facility: Asarco East
Helena Smelter; Subject: Sample
from EH-119 Well Construction;
Date: April 30, 2008;
Photographer: Linda Jacobson

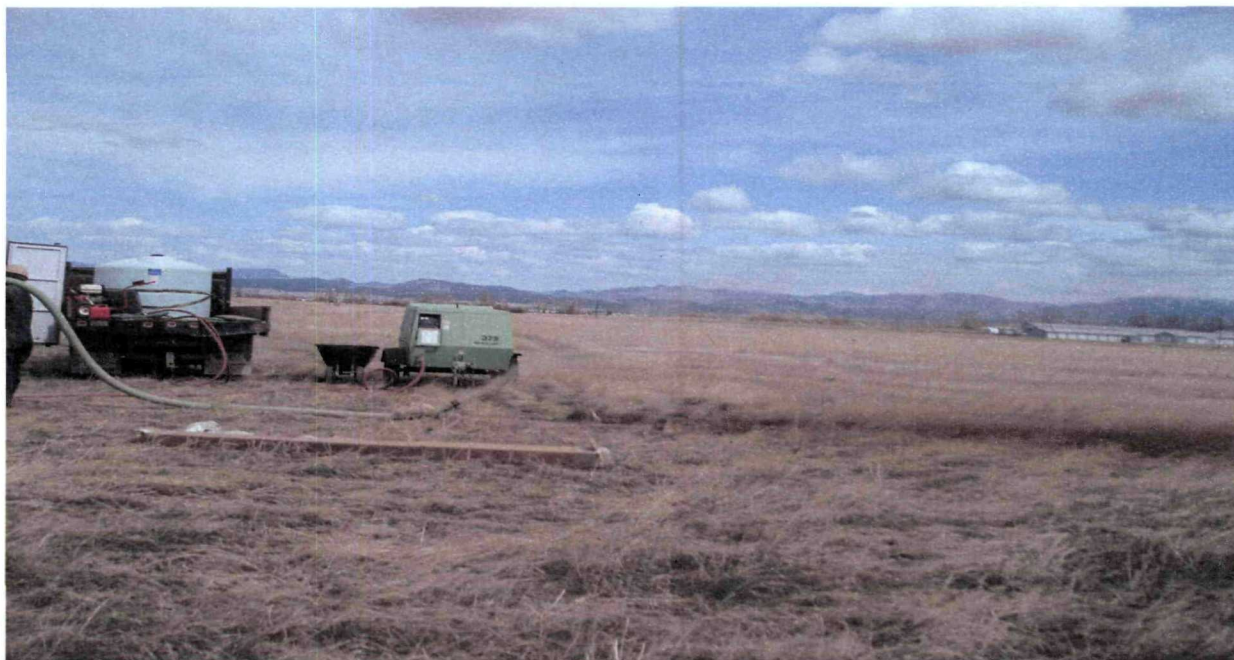
Photo 34; Facility: Asarco East
Helena Smelter; Subject: Water
Spray from Well Installation;
Date: April 30, 2008;
Photographer: Linda Jacobson

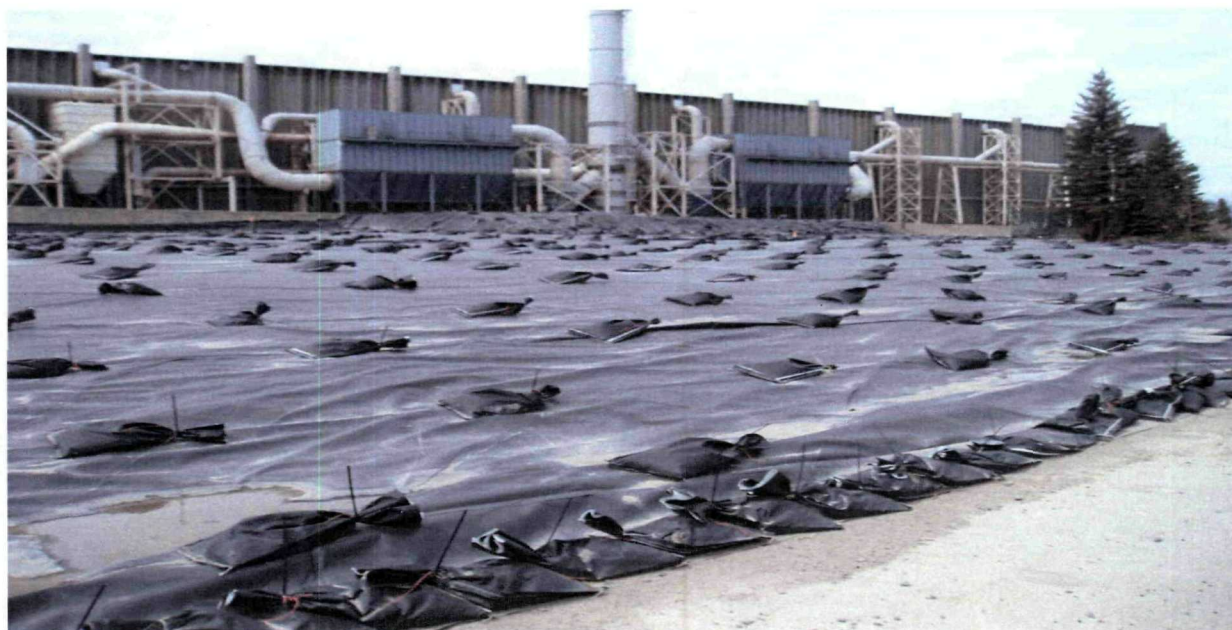
Photo 36; Facility: Asarco East
Helena Smelter; Subject:
Temporary Cap Secured with
Sand Bags; Date: April 30, 2008;
Photographer: Linda Jacobson

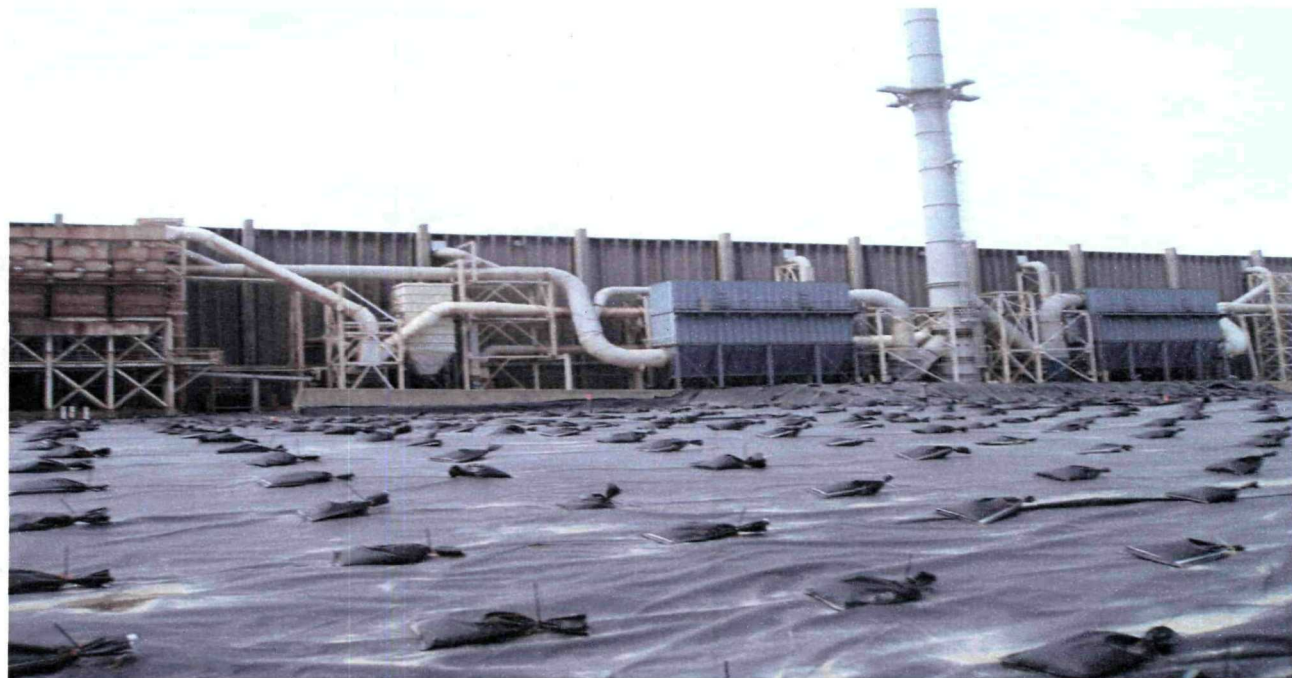
Photo 38; Facility: Asarco
East Helena Smelter;
Subject: Temporary Caps;
Date: April 30, 2008;
Photographer: Linda Jacobson

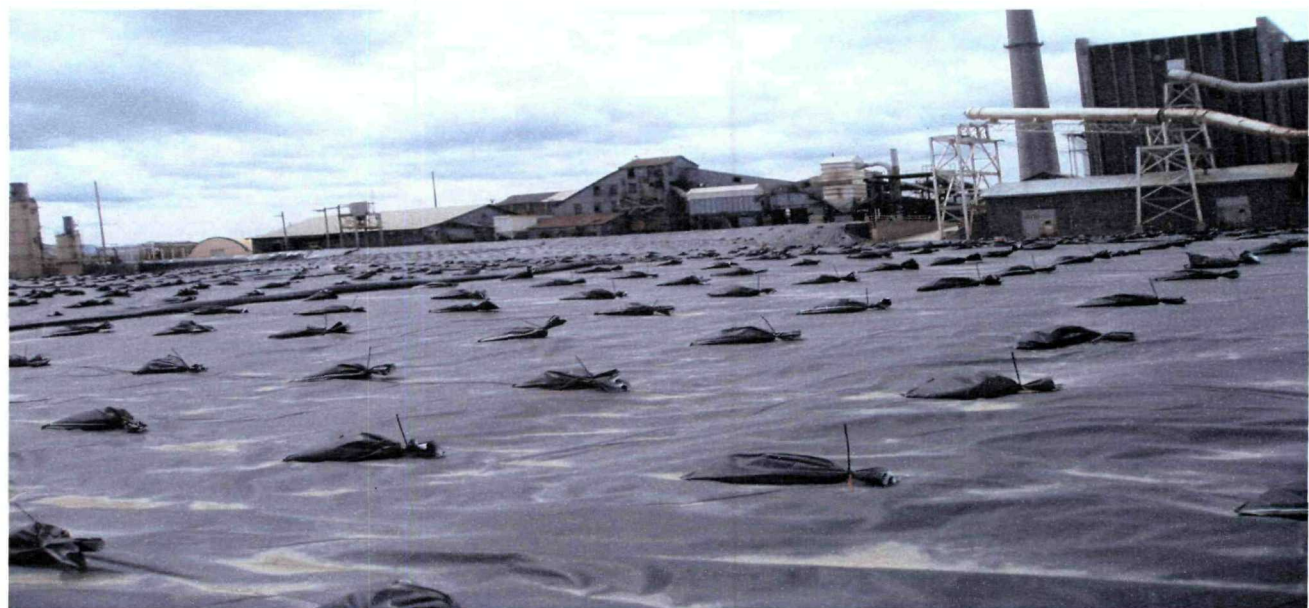
Photo 39; Facility: Asarco East
Helena Smelter;
Subject: Temporary Cap;
Date: April 30, 2008;
Photographer: Linda Jacobson

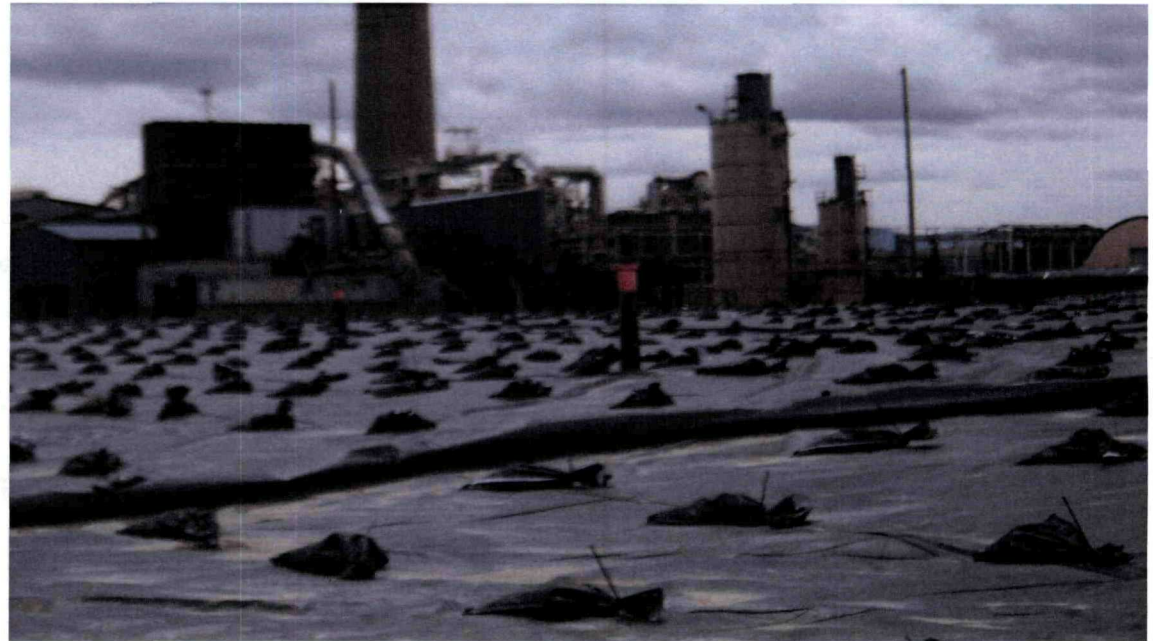
Photo 40; Facility: Asarco East
Helena Smelter;
Subject: Temporary Cap by CSHB
Date: April 30, 2008;
Photographer: Linda Jacobson

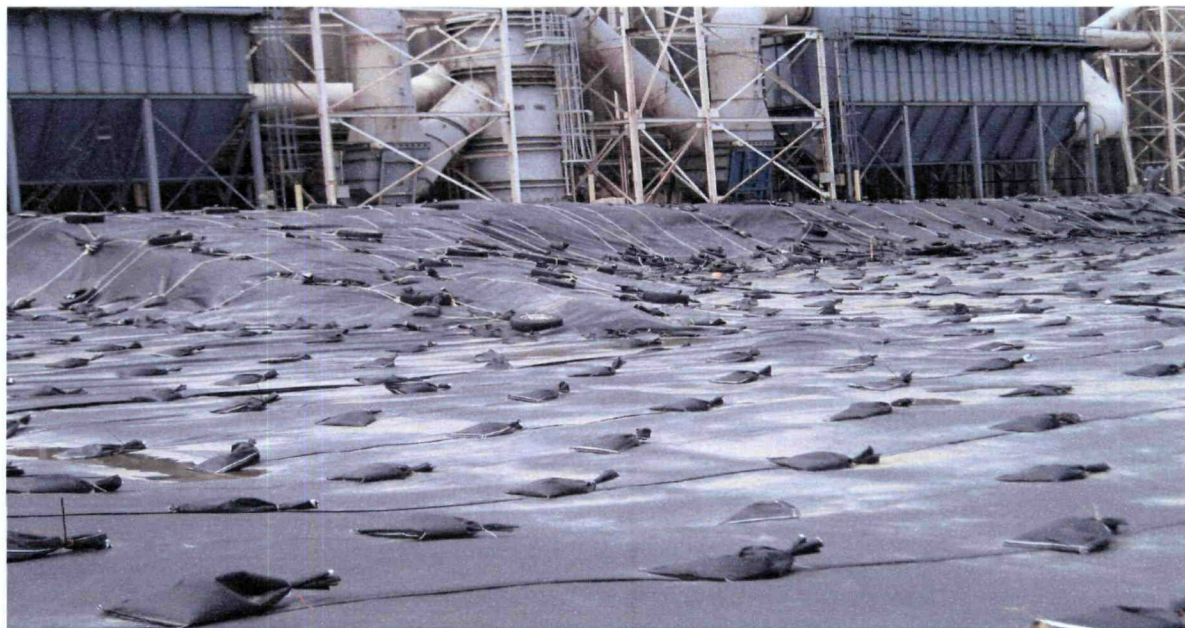
Photo 41; Facility: Asarco East
Helena Smelter; Subject:
Temporary Cap over
Speiss/Dross Plant Area
Date: April 30, 2008;
Photographer: Linda Jacobson

Mr. Miller, Mr. Nickel, and Ms. Jacobson then donned personal protective gear and inspected a portion of the temporary cap which had been installed over the former Speiss/Dross area. To help mitigate plume movement and reduce mass loading to the ground water, a slurry wall had been installed as an interim corrective measure at the former Speiss/Dross Plant area in fall 2007. Pending installation of a final cover or cap, a temporary HDPE cap was placed over this area. Ms. Jacobson was shown the liner repair around TW-1 (Test Well 1 used for the CDM pumping test). She also observed the liner beside the CSHB building which had to be secured by roped tires to prevent ballooning and tearing.

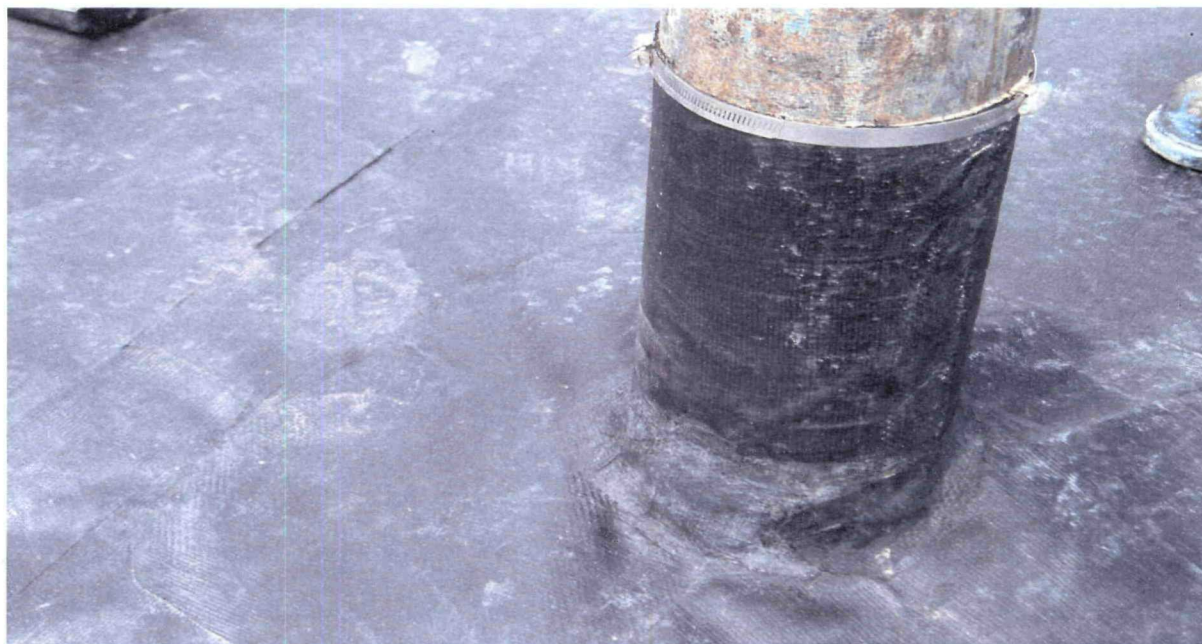
Photo 42; Facility: Asarco East
Helena Smelter; Subject: Repaired
Liner around Well Casing in Former
Speiss/Dross Plant Area
Date: April 30, 2008;
Photographer: Linda Jacobson

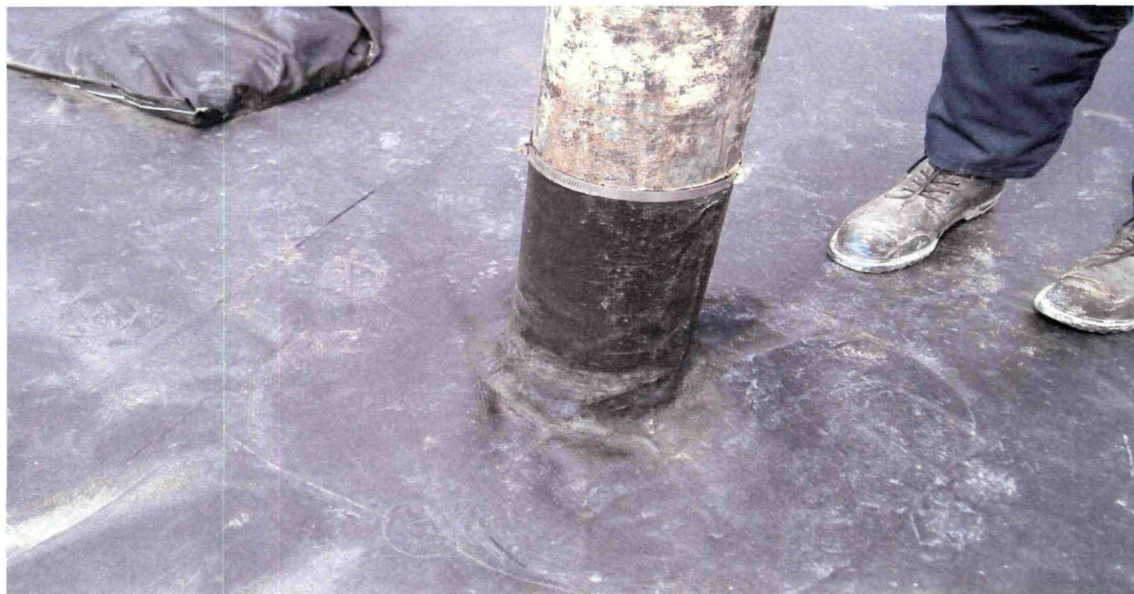
Photo 43; Facility: Asarco East
Helena Smelter; Subject: Repair to
Liner around Well at Former
Speiss/Dross Plant Area;
Date: April 30, 2008;
Photographer: Linda Jacobson

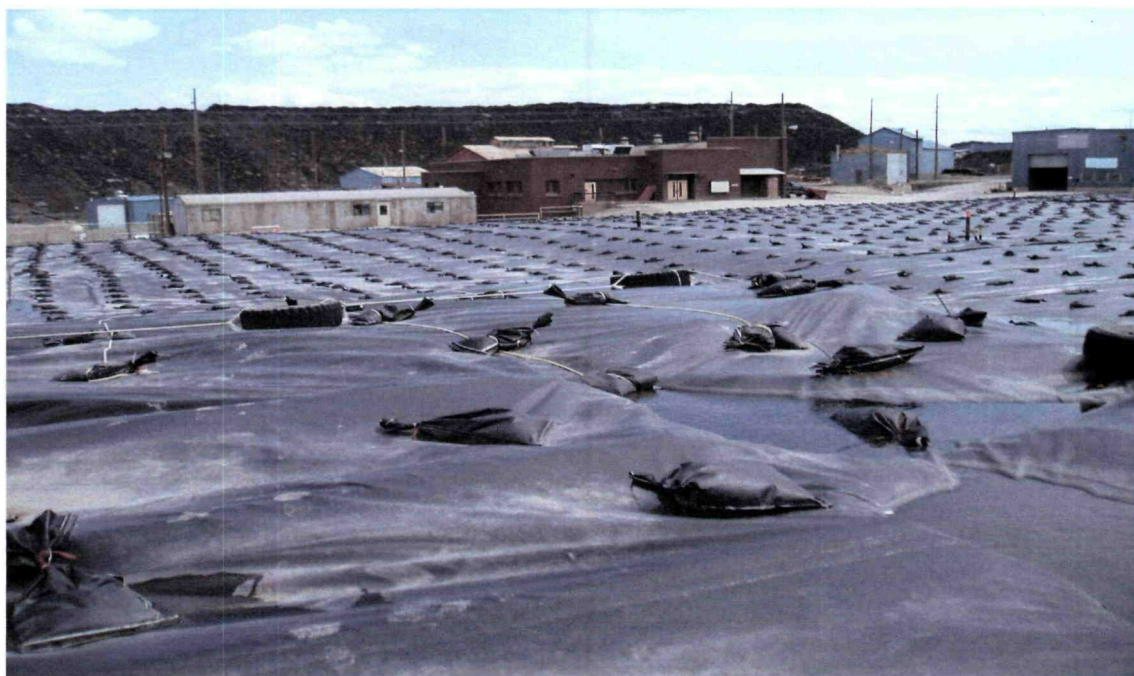
Photo 45; Facility: Asarco East
Helena Smelter; Subject:
Temporary Cap at Former
Speiss/Dross Plant Area;
Date: April 30, 2008;
Photographer: Linda Jacobson
